# Structural retrofitting of RC slabs using bamboo fibre laminate: Flexural performance and crack patterns

Bamboo fibre laminate  
Flexural performance  
Crack pattern  
Mode of failure  
Sustainable material  
Retrofit  
RC slab

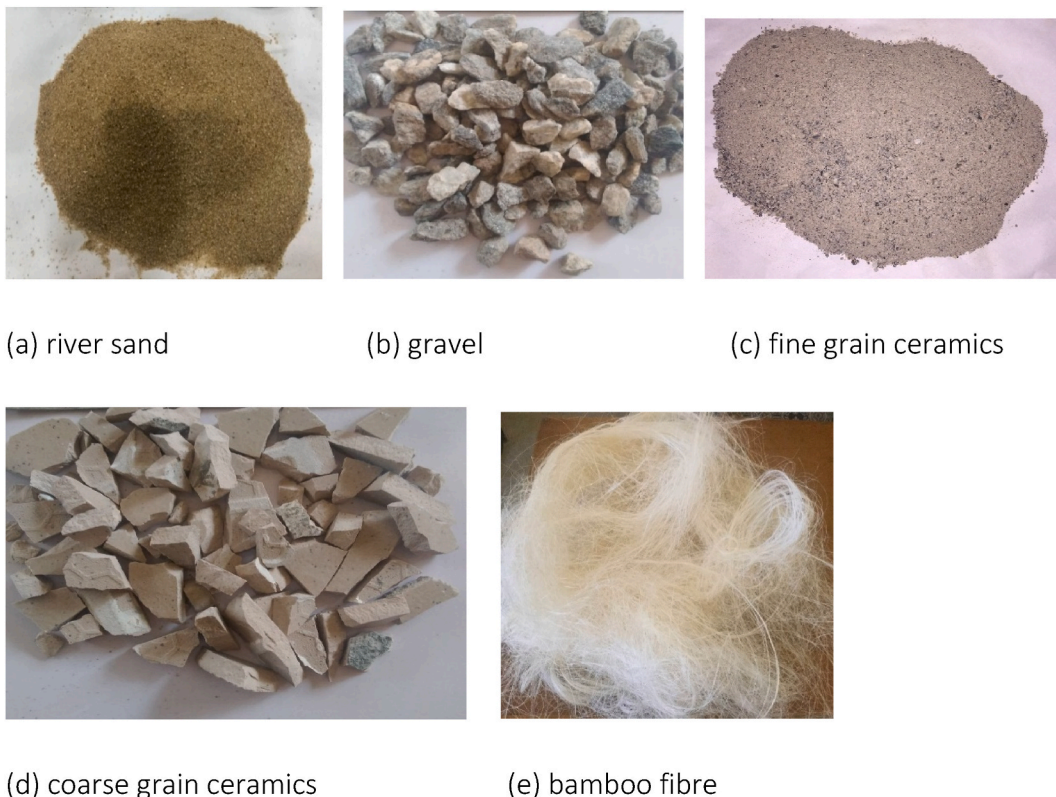
**Fig. 1.** Materials for fabrication of slabs.

The materials utilized in this study included grade 42.5 ordinary Portland cement, which falls in the category of an ASTM C150 standard type I multipurpose cement. Other materials were river sand as fine aggregate (< 4.75 mm), gravel as coarse aggregate (8–12 mm), and ceramics. Water for mixing was pure, colourless, freshwater, and odourless in accordance with specifications from ASTM C1602. Bamboo fibre was used for laminate fabrication. Fig. 1 depicts the materials used for fabrication of slabs.

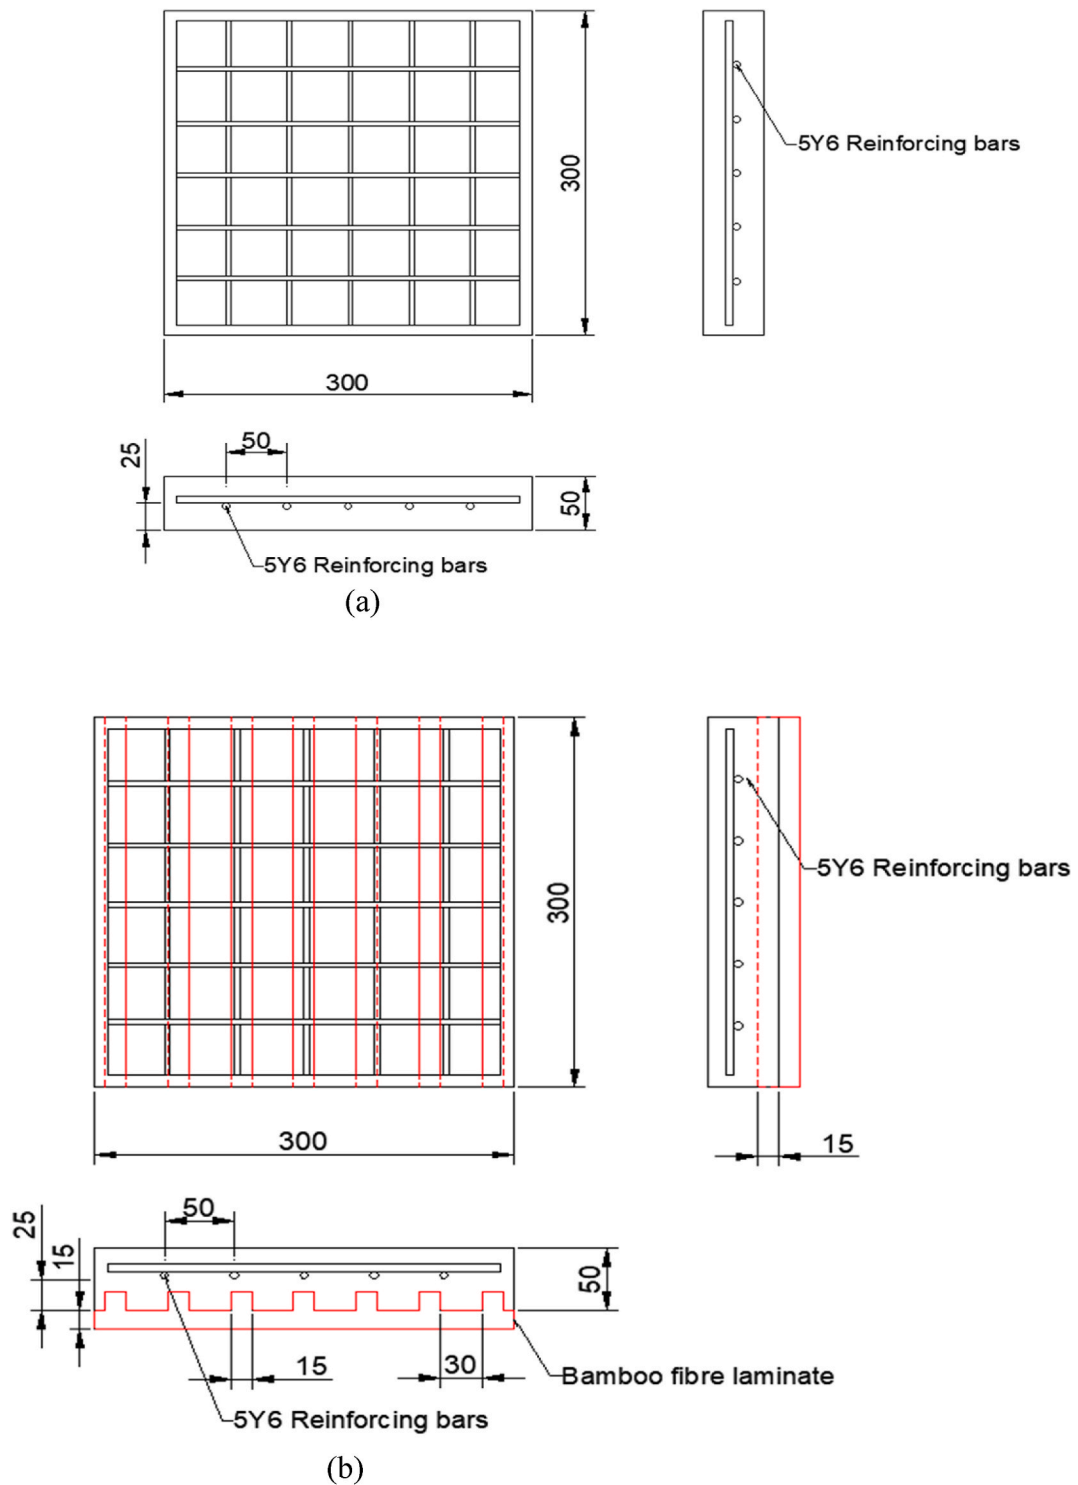
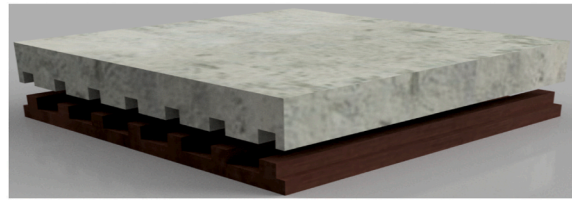
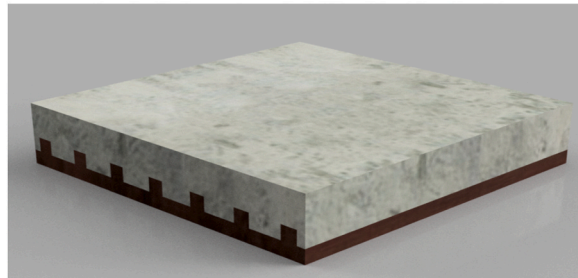
**Fig. 2.** (a) Plan, front view, and side view of slab and reinforcements (dimension: mm), (b) Plan, front view, and side view of slab, bamboo fibre laminate (BFL) retrofit, and reinforcements (dimension: mm), (c) 3D view of BFL and slab, (d) 3D view of joined BFL and slab.

This research required the use of 12 slab samples. The mixing of concrete was done manually. The constituents were mixed until a homogenous substance was formed. Three 50-mm layers of concrete were poured, each of which was tamped 25 times with a 12-mm tamping rod. In the formwork, there were 5 bars of 6 mm in diameter, with a spacing of 67.5 mm placed in both directions and soldered to hold reinforcements in place. Concrete biscuits of 15 mm in size were added to ensure the reinforcing bars did not touch the formwork and also ensured a 25 mm concrete cover in all directions of the slabs. Concrete was then poured into a rectangular formwork with the required specifications and allowed to set. After 24 h, the slabs were de-moulded and placed in a curing tank for 28 days to ensure their maximum strength was reached. The schematic views of the slab and reinforcements are displayed in Fig. 2.

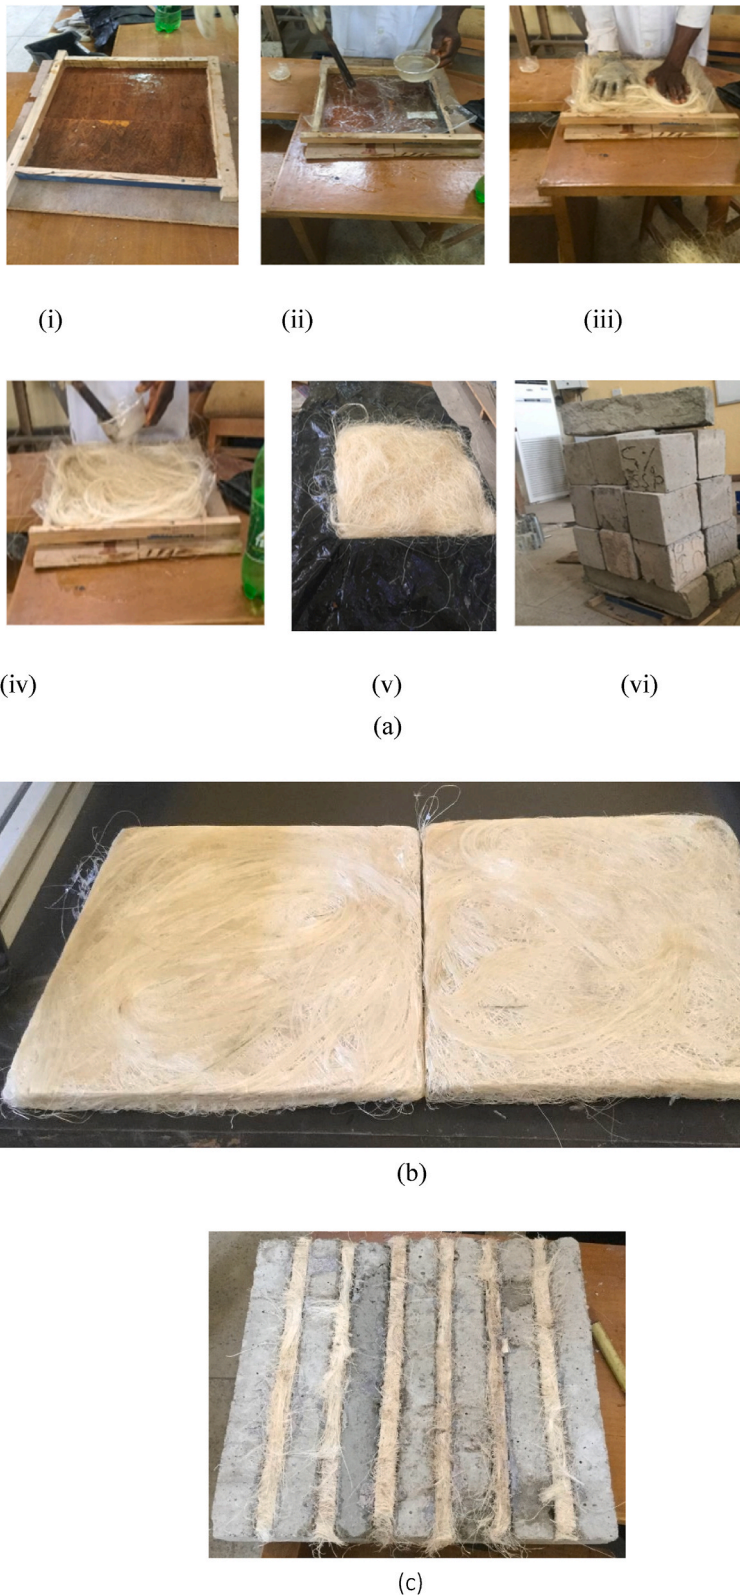
**Fig. 3.** (a) Bamboo fibre formation process: (i) Lubricating formwork, (ii) Addition of epoxy resin and hardener (2:1), (iii) Addition of bamboo fibre to formwork, (iv) Addition of extra layer of resin and hardener, (v) Bamboo fibre before being wrapped with nylon, (vi) Application of weight to compress bamboo fibre. (b) Fabricated BFL. (c) BFL used in NSM for slab.

Fig. 3a and b demonstrate the step-by-step procedures taken to fabricate the laminates used in this study, and Fig. 3c depicts BFL used in NSM for the slabs.

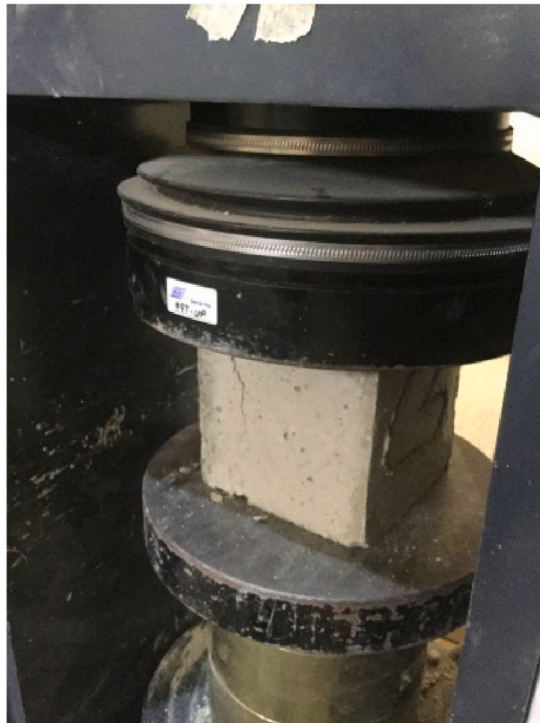
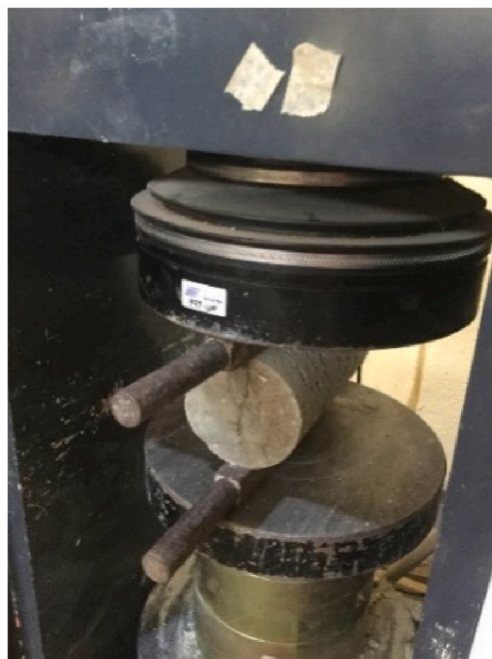
**Fig. 4.** (a) Compressive strength test on cube sample, (b) Splitting tensile strength test on cylinder sample.

The ability of concrete to withstand a compressive load without failure is known as its compressive strength. To minimize the amount of voids, the test was conducted by appropriately compacting concrete after it was poured into a mould with the dimensions of 150 mm × 150 mm × 150 mm. The mould was removed 24 h later. The apparatus used was the compression testing machine (Fig. 4a).

strength of concrete affects the extent and size of cracking in structures. The apparatus utilised was the compression testing machine but with a different arrangement to accommodate cylindrical samples (Fig. 4b).

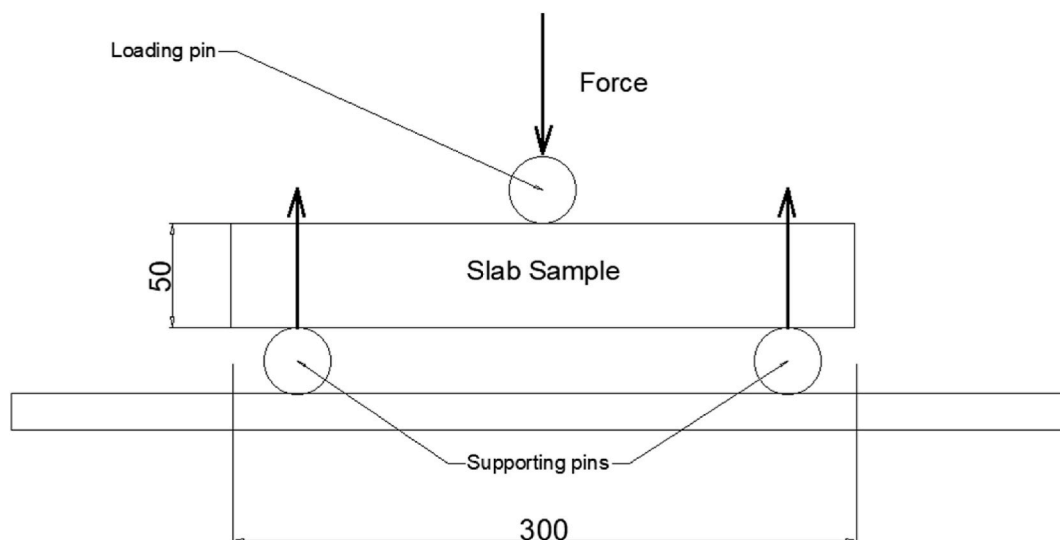
Fig. 6. Technical setup of three-point bending system of flexural strength test on slab samples (dimension: mm).

The slab sample was subjected to a continuous load during the test, which typically increased incrementally until the slab reached its maximum load-carrying capacity or failed. The greatest load that the slab sample could withstand was noted.

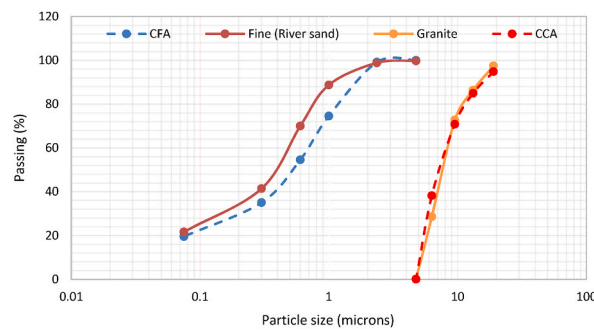
Fig. 7. Particle size distribution of CCA, CFA, river sand, and granite.

In Fig. 7, the particle size distribution of different aggregates is displayed. Ceramic coarse aggregate (CCA), coarse natural aggregate (granite), ceramic fine aggregate (CFA), and fine aggregate (sand) were examined. Sand and CFA were sieved using a range of no. 4 to 100 sieves, with openings ranging from 2.36 mm to 0.075 mm. Granite and CCA were also sieved but with a larger openings of 19–2.36 mm. According to British Standards (BS), both granite and CCA are considered coarse. Similarly, sand used in the study is also classified as coarse based on BS.

The size gradient can be utilised in the determination of the grade of aggregate. Aggregate could be graded as either well-graded meaning the gradation is close to the maximum density gradation line, gap-graded meaning it has only a small percentage of particles in the mid-size range, uniformly-graded meaning it is composed of mostly particles of the same size or open-graded meaning it contains only a small percentage of small-sized particles. The particle size distribution curve of fine aggregate and CFA represents well-graded aggregate, hence, the gradation and distribution line are close to the maximum density gradation line. The particle size distribution curve of coarse aggregate and CCA indicates uniformly-graded aggregate, accordingly, the gradation is mainly composed of particles of the same size. The well-graded fine aggregate employed in conjunction with uniformly-graded coarse aggregate yields a highly workable concrete mix with minimal void spaces, consequently, making the grade of used aggregate adequately efficient for concrete.

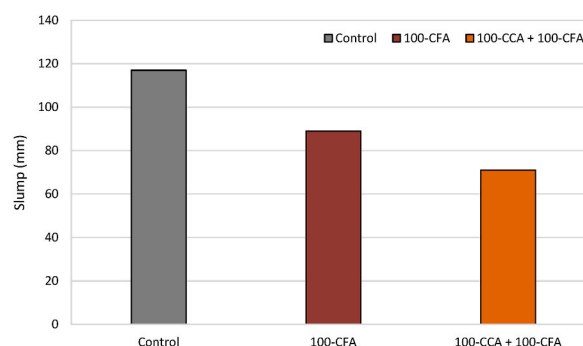
Fig. 8. Results of slump test.

The results of the slump test, representing the workability of the fresh concrete mixes, are demonstrated in Fig. 8. It was observed that the control concrete, which had a water-to-cement ratio of 0.5, exhibited the highest slump value of 117 mm. The mix with 100% CFA replacement gave a slightly lower slump value of 89 mm. The lowest slump value of 71 mm was recorded for the mix with 100% CCA and CFA substitution. From the figure, it can be deduced that an increase in the percentage substitution of ceramic aggregates led to a reduction in the slump value.

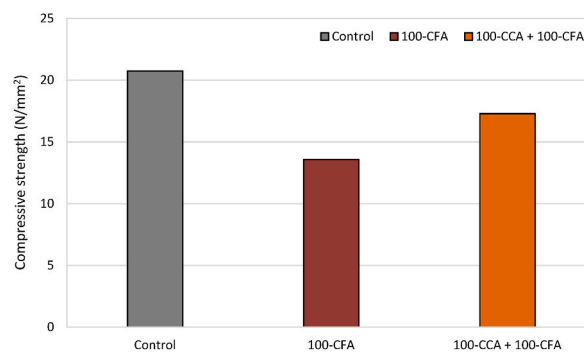
Fig. 9. Average compressive strength results of concrete samples after 28 days of curing (N/mm<sup>2</sup>).

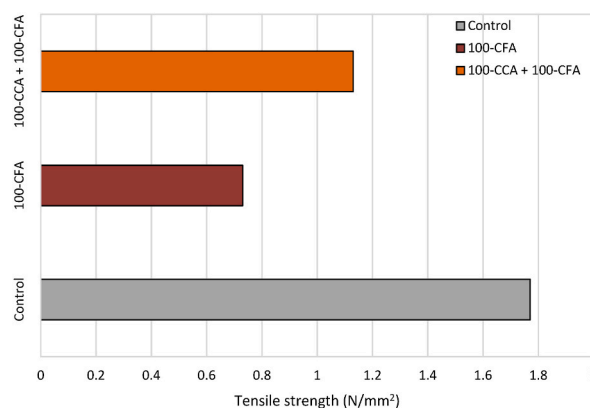
Fig. 10. Average splitting tensile strength results of concrete samples after 28 days of curing.

A splitting tensile test was done on cylindrical concrete samples to assess their resistance to the tension. The samples consisted of a control mix, 100-CFA, and 100-CCA + 100-CFA. The splitting tensile strength results are illustrated in Fig. 10.

As can be seen in Fig. 10, the highest average splitting tensile strength was achieved by the control mix as  $1.77 \text{ N/mm}^2$ , while, the lowest was obtained by the 100-CFA mix as  $0.73 \text{ N/mm}^2$ .

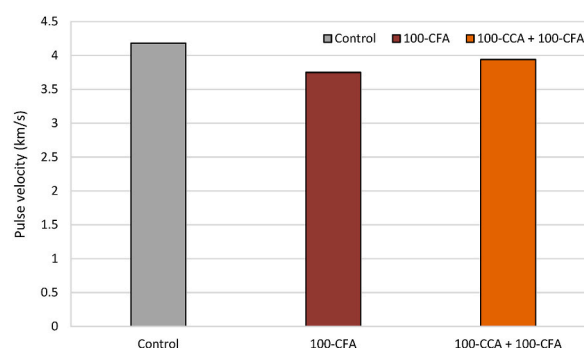
Fig. 11. Pulse velocity results.

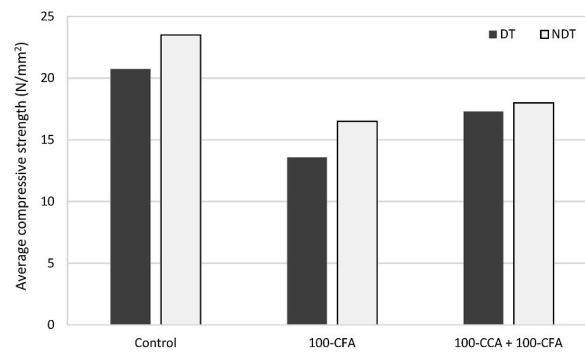
**Fig. 12.** Comparison of average compressive strength values obtained from destructive test (DT) and non-destructive test (NDT) for various concrete mixes.

Fig. 12 presents the results of the Schmidt hammer testing performed on the slab samples. Each sample was subjected to three repeated impacts with the Schmidt hammer, and the rebound values were recorded. The average rebound value (R-value) and the corresponding estimated compressive strength were calculated using established conversion charts specific to the concrete mix design and testing standards.

The Schmidt hammer test conducted on the slab samples gave an average rebound value of 26.17, reflecting a moderate variation in the surface hardness across the samples. The results suggested NS1B had the best surface layer, while NS2B had the worst surface layer among the samples.

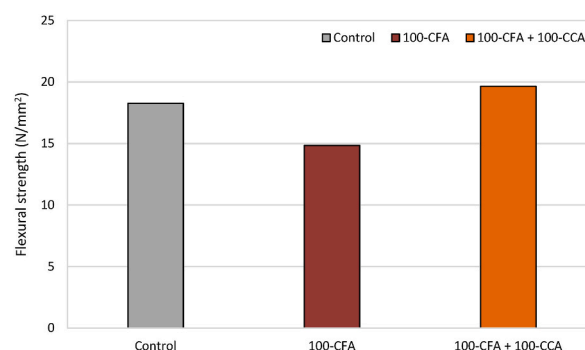
**Fig. 13.** Flexural strength values of non-retrofitted slab samples.

It is a well-known fact that concrete exhibits limited strength when subjected to the tension and is comparatively stronger when subjected to the compression. However, the inherent deficiency of the flexural strength in concrete can be effectively improved through the incorporation of fibres. The presence of fibres introduces a crack arrest mechanism, enhancing the stiffness and toughness of concrete. This established phenomenon contributes to a noticeable increase in the flexural strength [25]. Now that challenges related to sustainability and global warming have come to light, bamboo is a popular topic of discussion. Figs. 13 and 14 display the flexural strength values of the non-retrofitted slabs and retrofitted slabs, respectively.

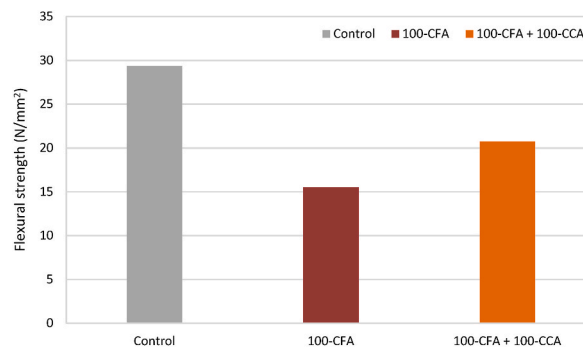
Fig. 14. Flexural strength values of retrofitted slab samples.

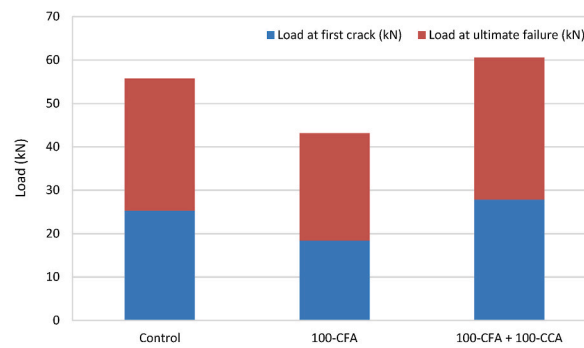
Fig. 15. Load at first crack compared to ultimate failure load (non-retrofitted slabs).

Figs. 15 and 16 illustrate loads at first cracks compared to ultimate failure loads for the non-retrofitted slabs and retrofitted slabs, respectively. Table 3 provides the failure modes seen in the slab samples. The initial crack in the case of the control slabs, developed an average load of 42.45 kN, which was 67.79% higher than that of the slabs without retrofitting. For the retrofitted 100-CFA slabs, the first crack occurred at an average load of 17.65 kN, representing a decrease of 4.08% compared to the 100-CFA slabs without retrofitting. Notably, when subjected to load until the ultimate failure, there was only a marginal 4.44% improvement despite retrofitting with BFL. As for the retrofitted 100-CFA + 100-CCA slabs, the initial crack was observed at an average load of 31.4 kN, slightly higher by 12.75% compared to the mix without retrofitting.

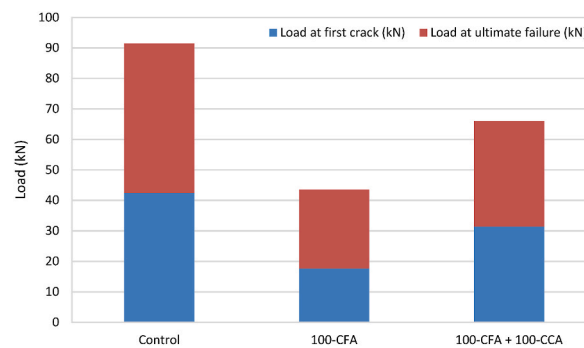
Fig. 16. Load at first crack compared to ultimate failure load (retrofitted slabs).

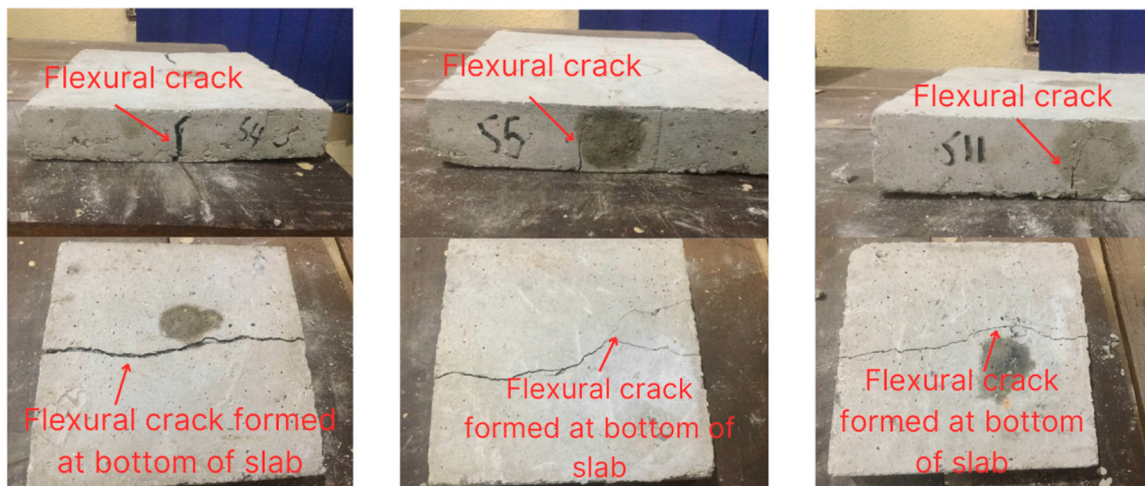
(a) NS1A front and bottom views (b) NS1B front and bottom views (c) NS2A front and bottom views

**Fig. 17.** Failure modes and crack patterns for NS1A, NS1B, and NS2A.

Among the non-retrofitted slabs, as the load was progressively applied until reaching the ultimate failure, flexural cracks in the form of flexural mode failure were observed across all the slab samples in this category. Additionally, at the bottom of all non-retrofitted slabs, a longitudinal flexural failure was seen, extending from one end of the slabs to the other.

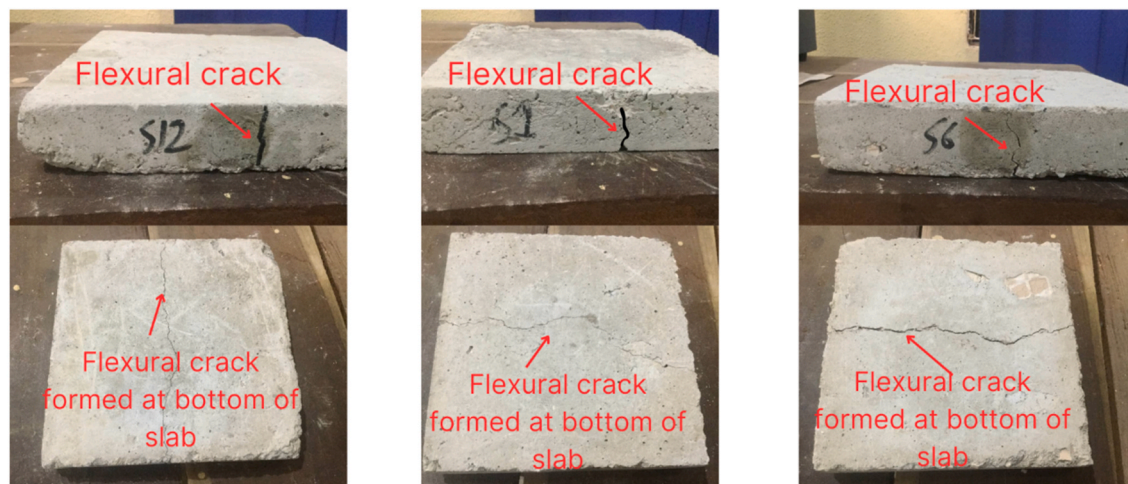
(a) NS2B front and bottom views (b) NS3A front and bottom views (c) NS3B front and bottom views

**Fig. 18.** Failure modes and crack patterns for NS2B, NS3A, and NS3B.

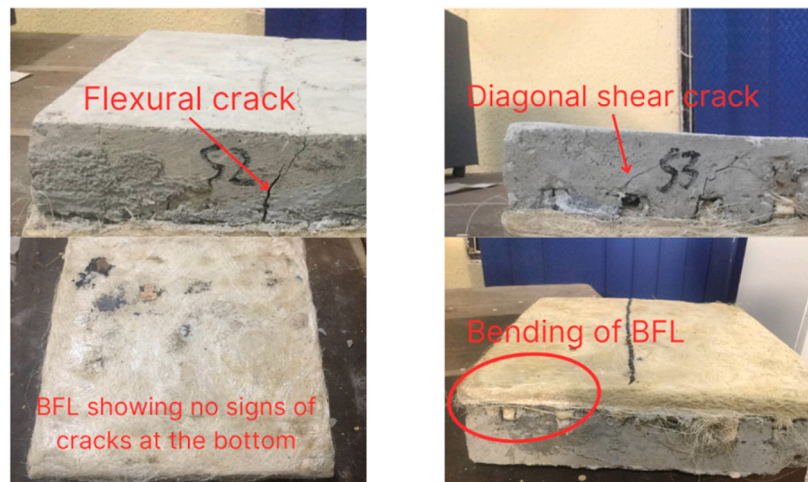
(a) RS1A front and bottom views (b) RS1B front and bottom views

**Fig. 19.** Failure modes and crack patterns for RS1A, RS1B, RS2A, and RS2B.

In contrast, the retrofitted slabs exhibited three distinct types of failures: (i) diagonal shear failure, (ii) flexural failure, and (iii) debonding between BFL and the slabs. Among the retrofitted slabs, RS1B, RS2A, RS2B, and RS3A experienced failure primarily due to the diagonal shear, whereas RS1A and RS3B failed due to the flexural stress. Notably, RS3A displayed a significant occurrence of debonding between the slab and BFL. Despite reaching the ultimate failure, none of BFLs in the retrofitted slabs showed visible cracks or noticeable damage. They remained intact throughout the tests. However, it was observed that BFLs experienced bending at the support points during the tests.

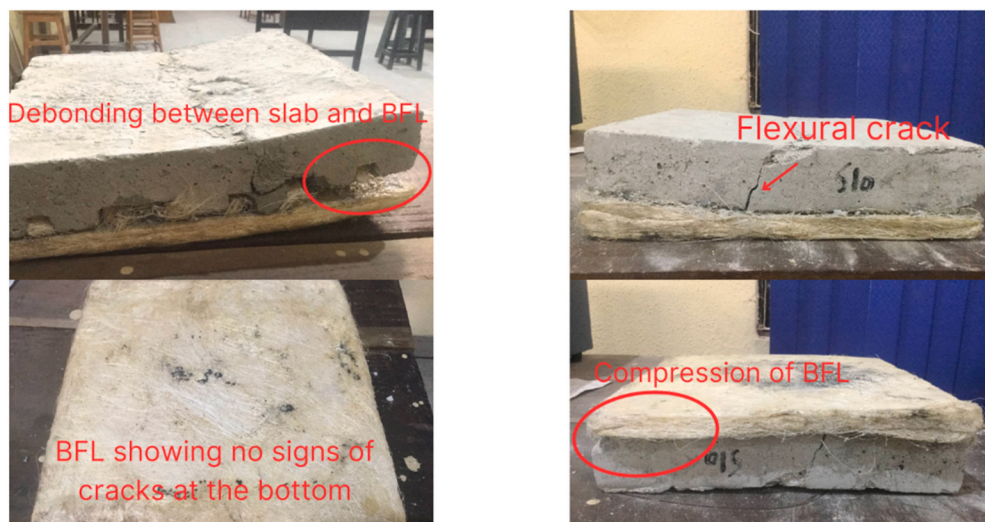
(a) RS3A front and bottom views

(b) RS3B front and bottom views

**Fig. 20.** Failure modes and crack patterns for RS3A and RS3B.
